June 12, 2014

Site: Sample address
Tacoma, WA 98407

At your request, a visual inspection of the above referenced property was conducted on June 10, 2014 . An earnest effort was made on your behalf to discover all visible defects, however, in the event of an oversight, maximum liability must be limited to the fee paid. The following is an opinion report, reflecting the visual conditions of the property at the time of the inspection only. Hidden or concealed defects cannot be included in this report. No warranty is either expressed or implied. This report is not an insurance policy, nor a warranty service.

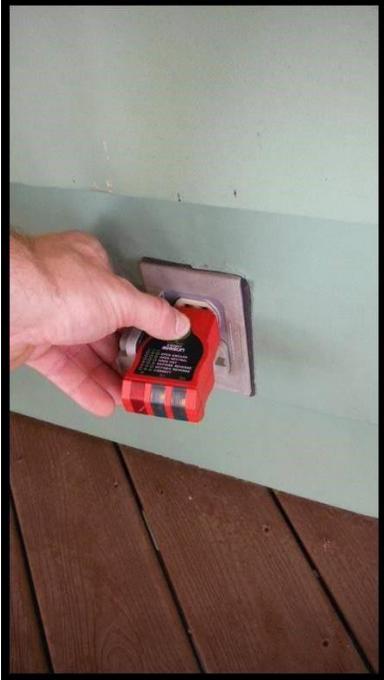
At some areas - This structure is partially protected by using Ground Fault Circuit Interrupt outlets at some of these locations: Outlets within 6' of a water source, any outside outlets, in the garage, and any outlets in an unfinished basement. Any areas not protected should be considered for installation as they afford inexpensive protection from electrical shock.

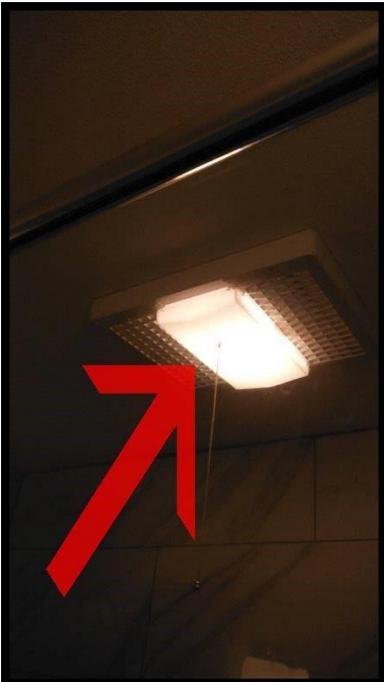
Bathroom #2:

Action Necessary - The lighting in this bathroom needs immediate repair. There is a light fixture installed in the shower that is not rated for a wet area. Please replace with an appropriate unit to guard against electrical shock.

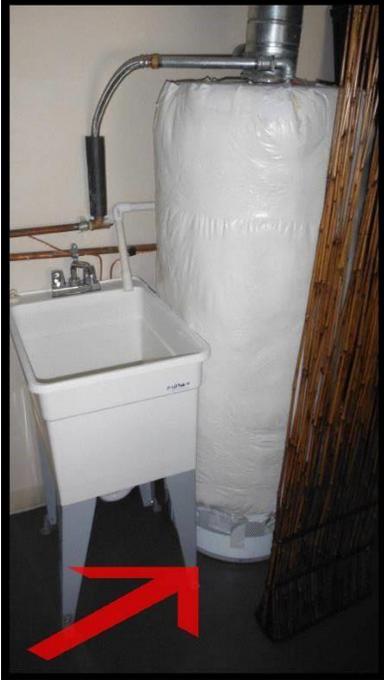
It shows some age, but it appears sound.

I am unable to tell when the water was installed. This water heater is improperly installed if installed in recent years. This water heater needs to be sitting on an elevated platform or stand unless it is a FVIR system. (Flammable Vapor Ignition Resistant) 2012 International Residential Code 2801.6.

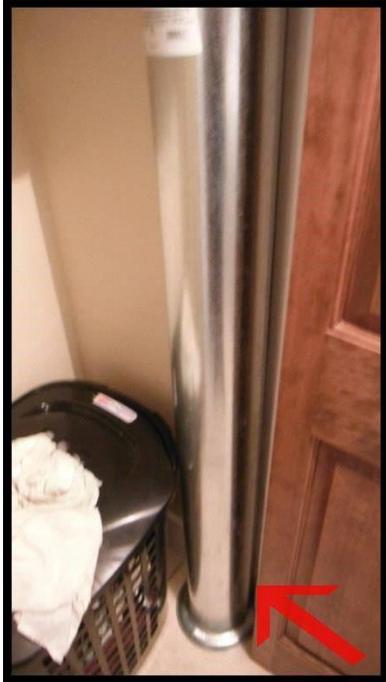
Attention Needed - The flue piping needs some minor attention or adjustment in the upstairs closet. The B-vent needs 1" clearance from combustible materials. Please see a licensed contractor to review this situation.

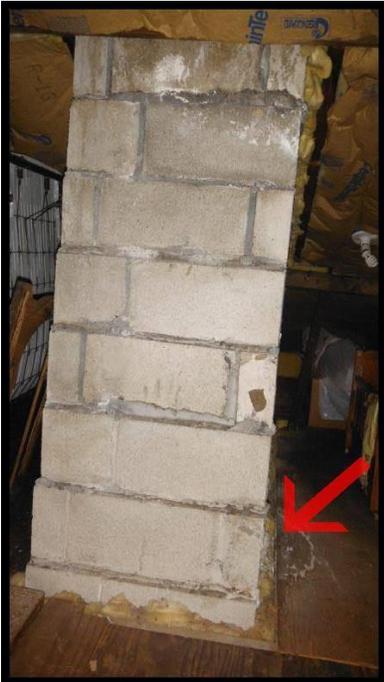
There is water staining on the attic floor. The stains are not currently wet nor do they have an elevated moisture content.

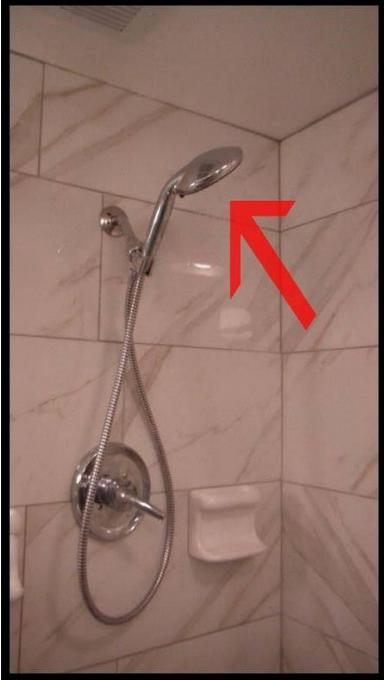
Action Necessary - A condition exists in the water supply that restricts water flow to a degree that repairs may be necessary.

This condition was noted in the downstairs bath when filling the tub and also when operating the downstairs bathroom shower.

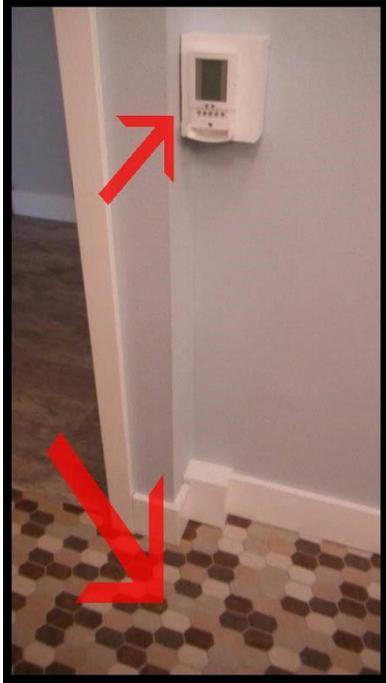
Attention Needed - The flooring in this bathroom is in need of attention.

The flooring in the bathroom has an in-floor electric heating system installed in it. This system seems to be improperly installed and not functioning at the time of the inspection. The tiles are laying unevenly and the system did not respond. (FYI I have this same system in my house and am very pleased with it)
